AFRL-ML-WP-TR-2001-4102

**FRACTURE BEHAVIOR OF A Si_3N_4 -BN
FIBROUS MONOLITH CERAMIC**

FINAL REPORT FOR PERIOD 01 OCTOBER 1999 - 01 APRIL 2001

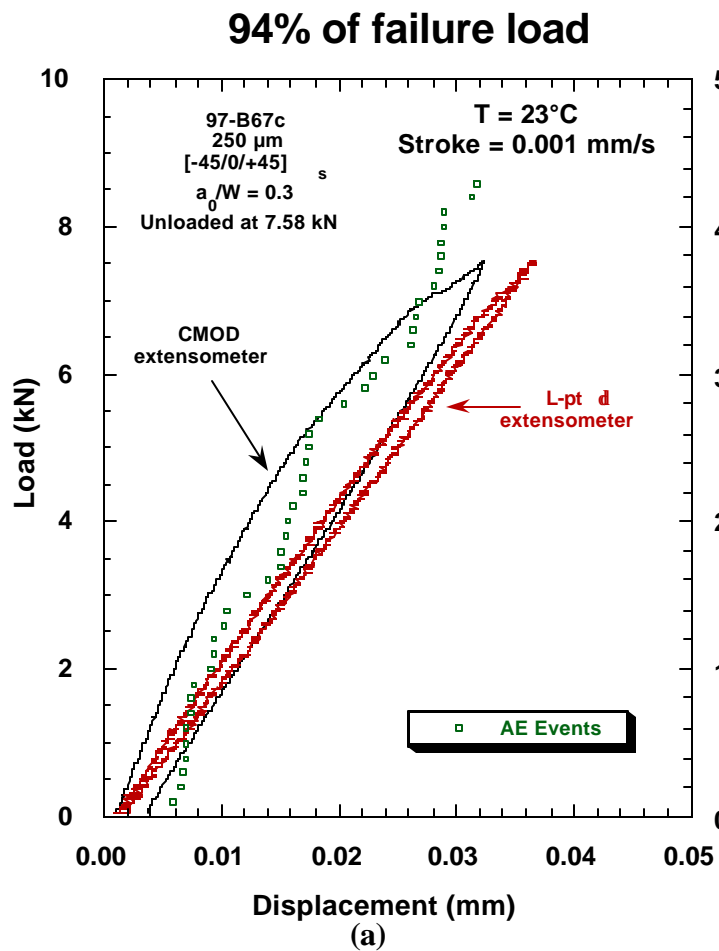
Figure 6.9 Results of load-unload testing a FM specimen with the coarser microstructure and an a_0/W of 0.3 at room temperature. (a) load versus displacement plot, (b) x-ray radiograph, (c) thermal diffusivity image, (d) ultrasonic c-scan, (e) acoustic emission histogram.

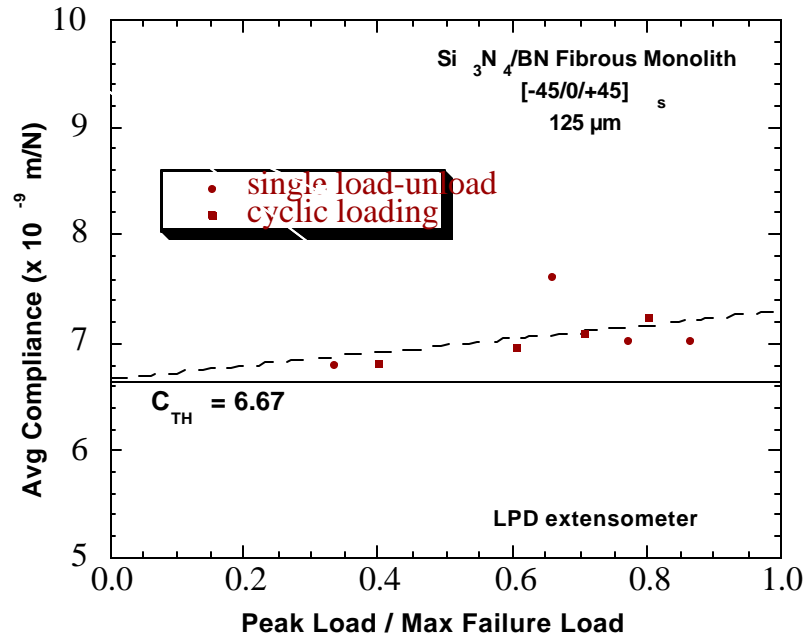
Figure 6.14 (a) Plot showing the curve fit of the experimental compliance data used to predict the compliance at failure for the material with the smaller microstructural features.

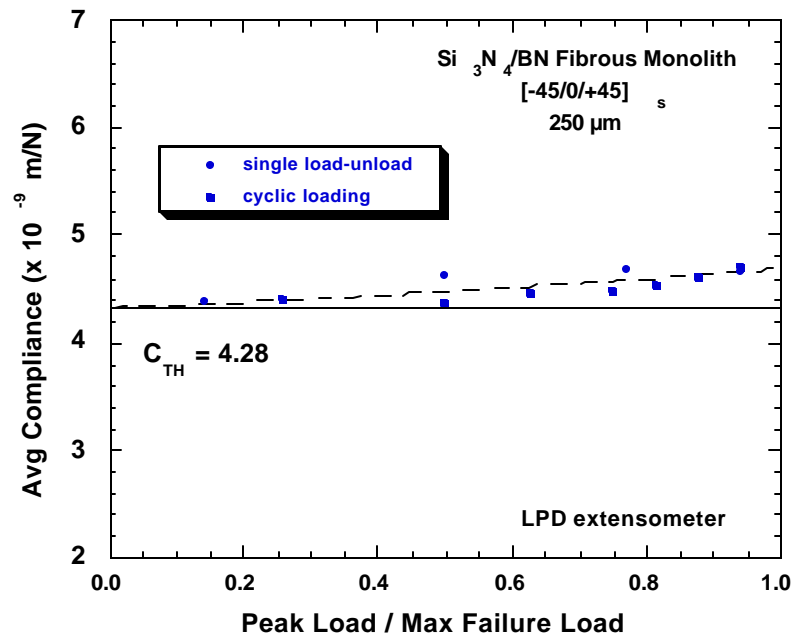
Figure 6.14 (b) Plot showing the curve fit of the experimental compliance data used to predict the compliance at failure for the material with the smaller microstructural features.

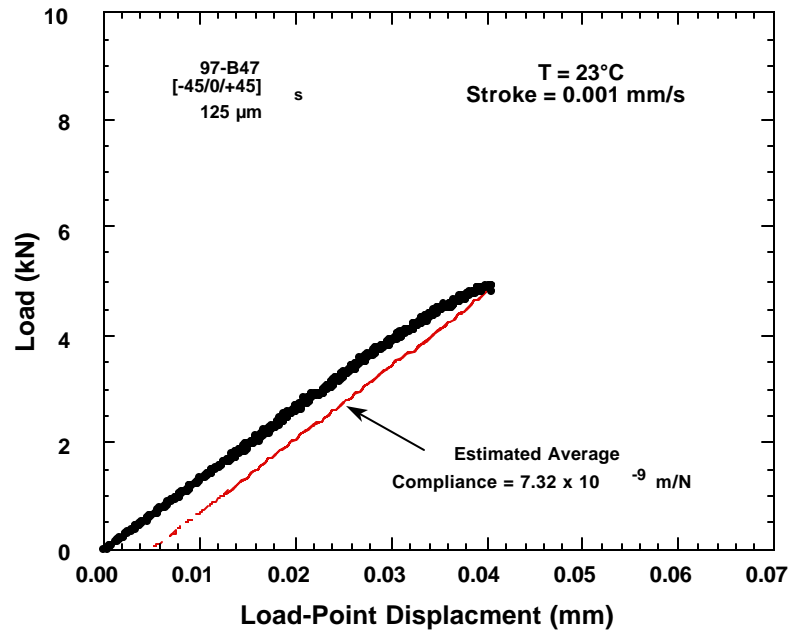
Figure 6.15 (a) Plot illustrating how the estimated failure compliance was used to discount the elastic energy at failure for the material with the smaller cell bundles.

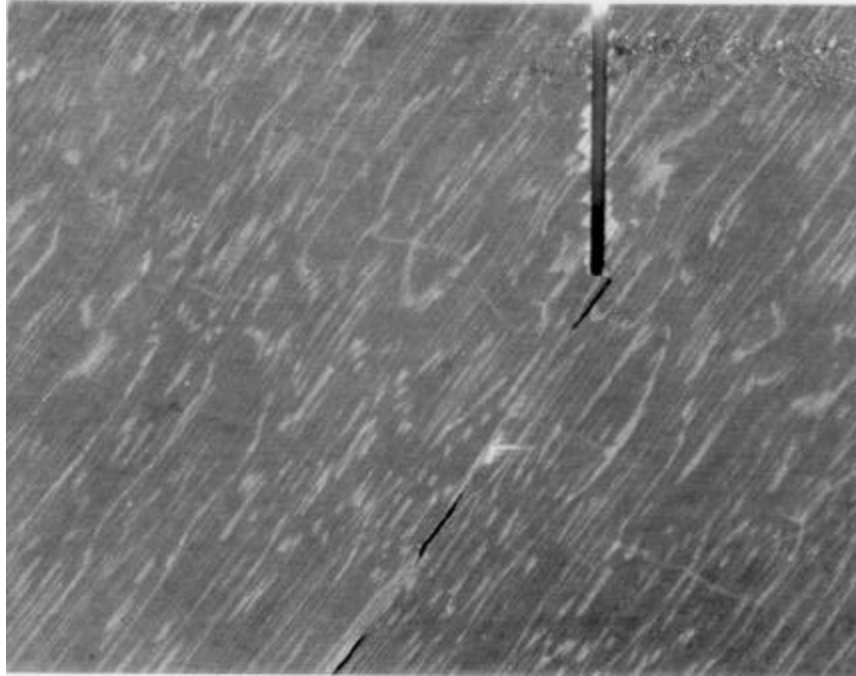
Figure 7.1 Micrograph at 6.3x of Si_3N_4 -BN fibrous monolith [-45/0/+45]_s with 125 μm cells (2-1 mm multi-filament strands) showing crack with 45° orientation coming from the notch.

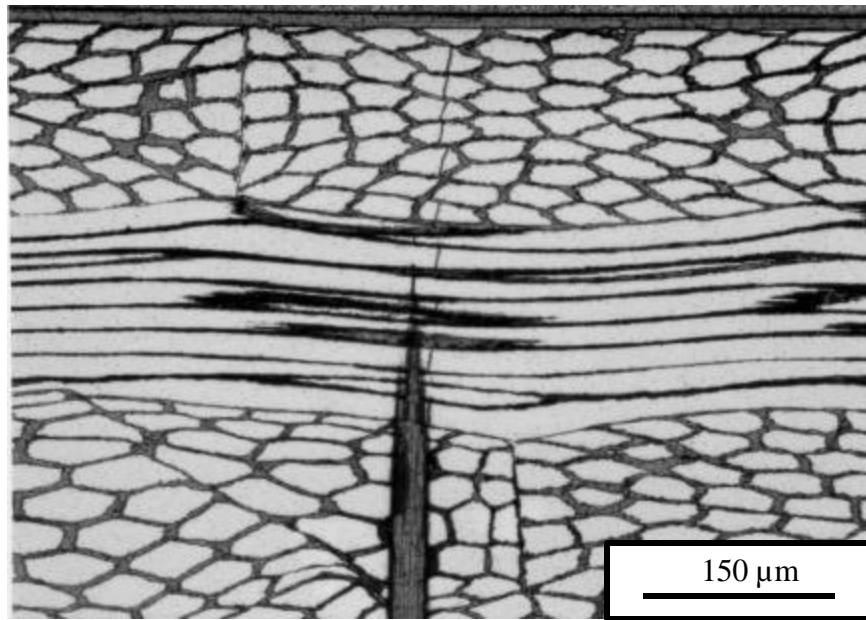
Figure 7.3 (a) Micrograph at 32x of showing an example of the cracks found behind the notch in the case of each single load-unload test.

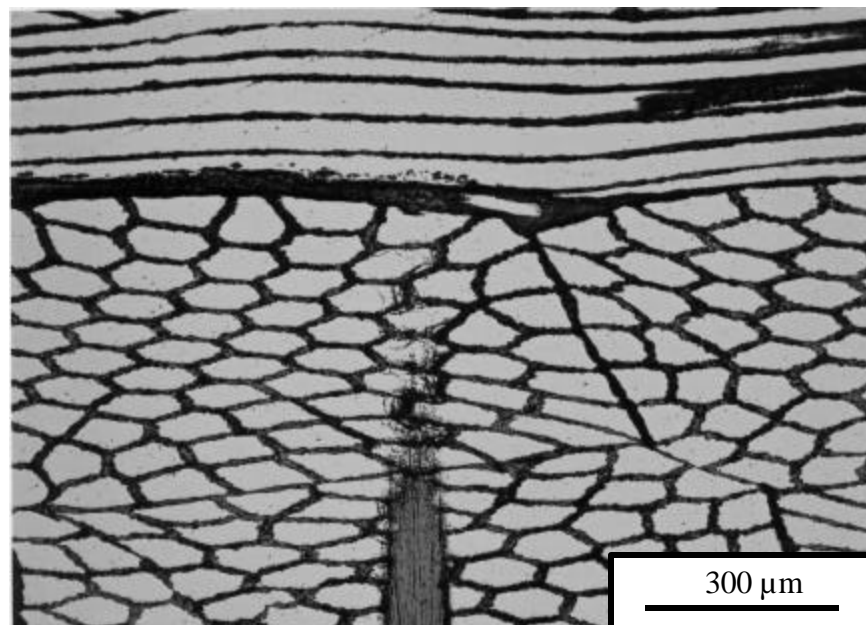
Figure 7.3 (b) Micrograph at 64x of illustrating how no cracks are found in untested notched specimens.

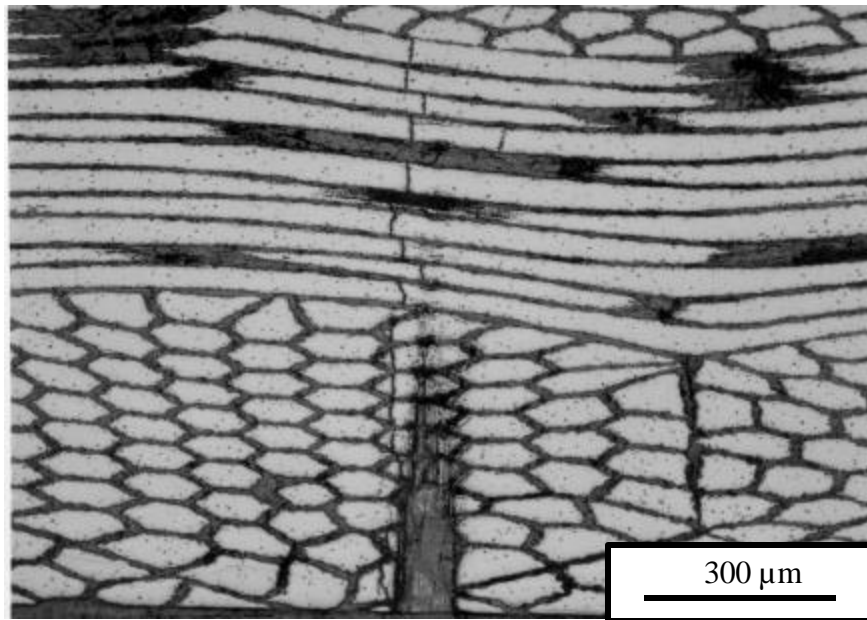
Figure 7.5 Micrograph of 97-B49b section #1 after polishing down through the notch. There is a crack adjacent to the notch.

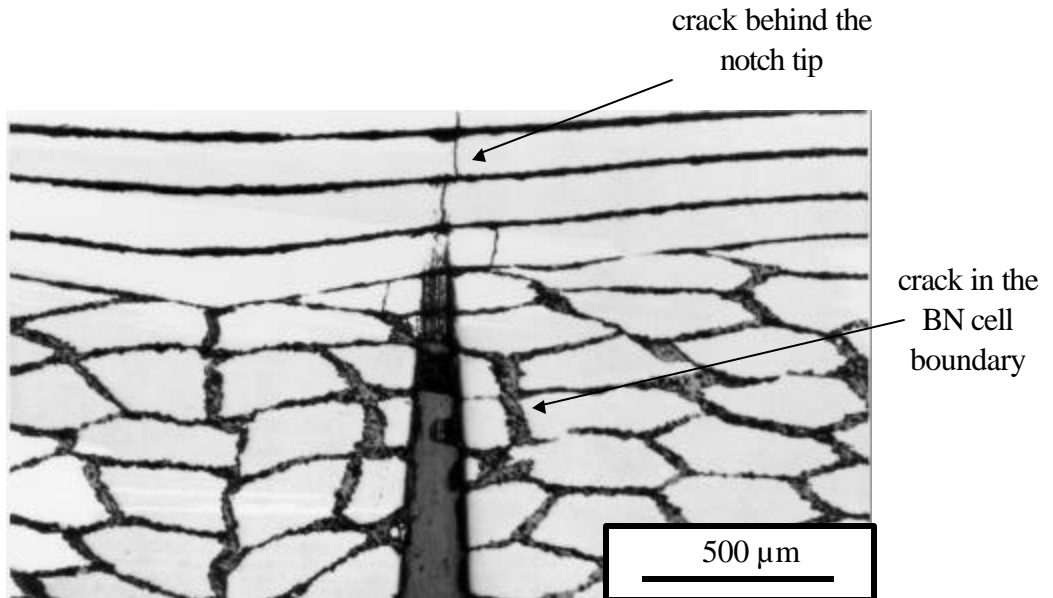
Figure 7.6 Micrograph of 97-B67c section #1 after polishing down through the notch. There is a crack adjacent to the notch and in the BN boundary near the notch.

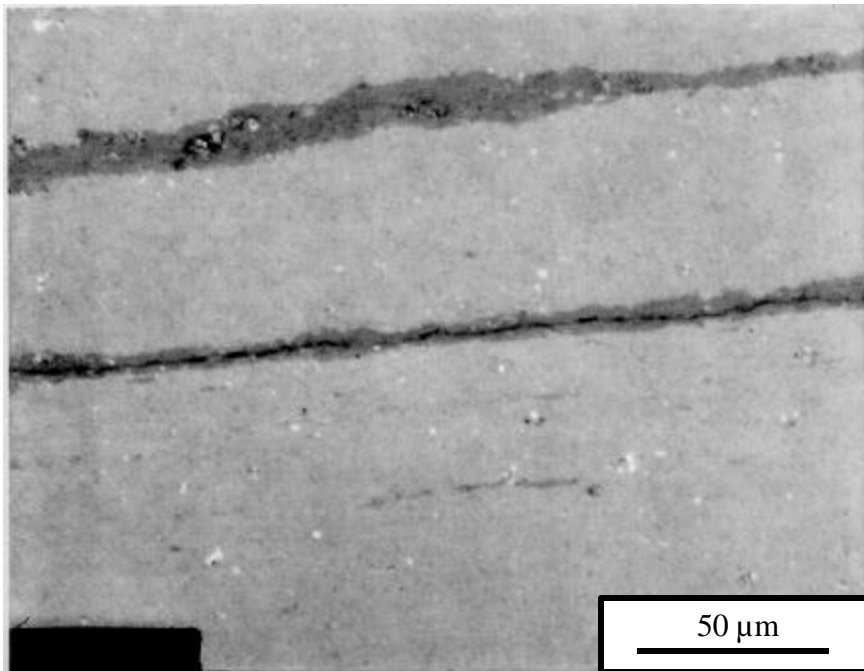
Figure 7.7 Micrograph which demonstrates how fine the cracks in the BN are even when tested near failure.

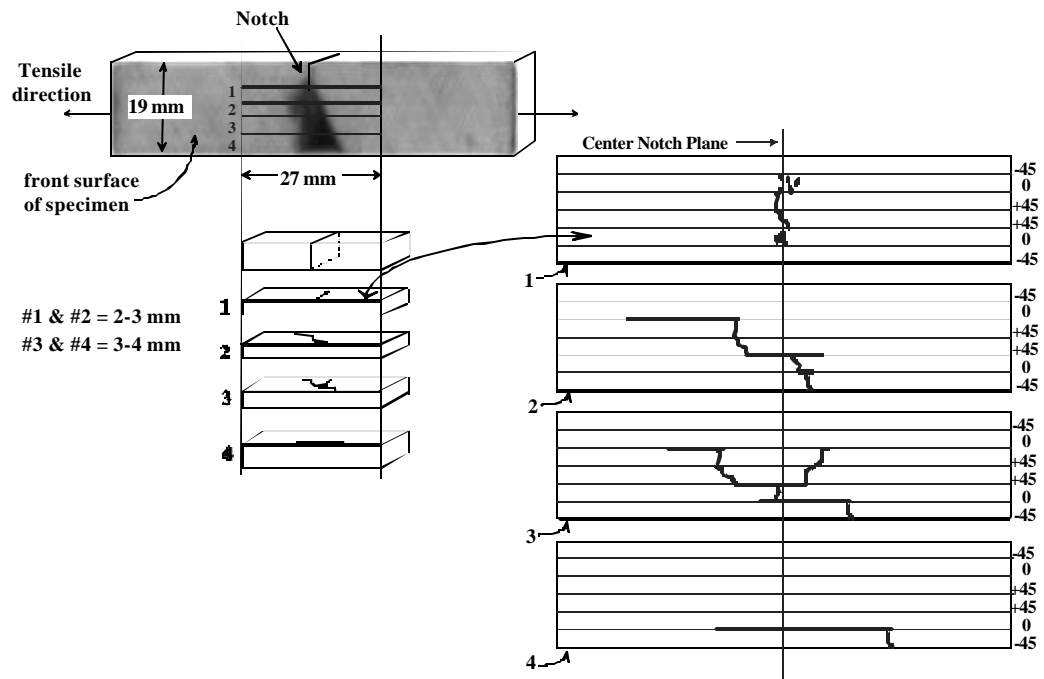
Figure 7.9 Microscopic sections compared to the x-ray radiograph. Sketches from individual specimen sections were drawn from polished sections.

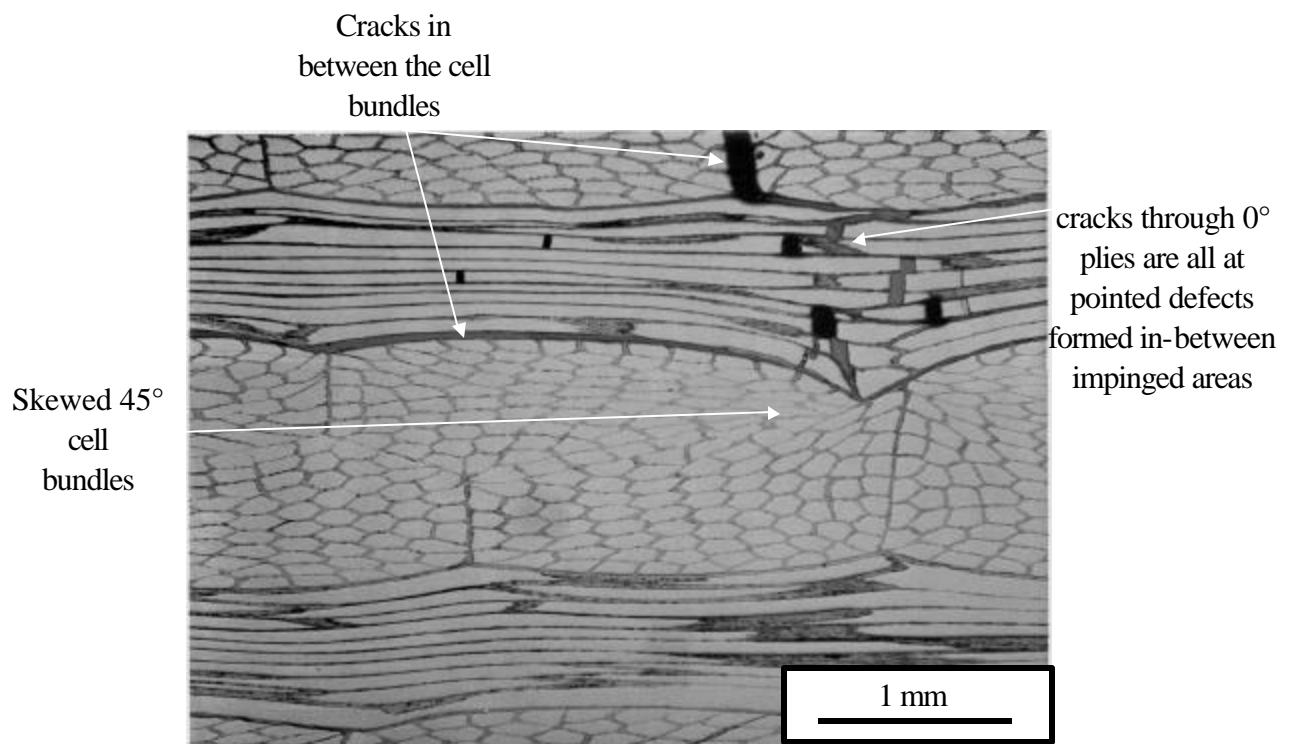
Figure 7.10 Micrograph illustrating that even in the presence of processing defects (skewed cell bundles) the preferred crack path is the cell bundles and at the defects formed presumably due to the impinged 0° cells
